NonUnion Fracture

Dr. Greg Hayes Arapahoe Animal Hospital

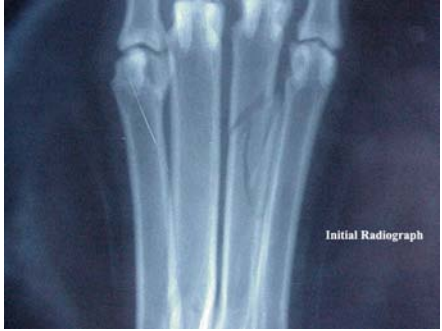
<p>Initial Radiograph</p>	<p>Patient: Ursa, Rottweiler Problem: Nonhealing fractured metatarsal Previous Therapies:</p>

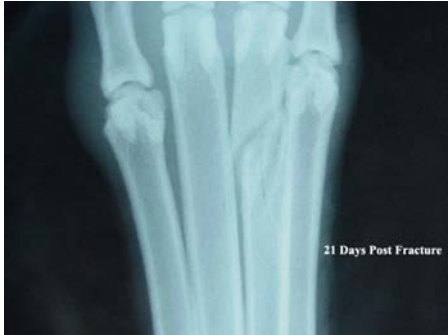
<p>21 Days Post Fracture</p>	<p>K Laser Protocols: Fractures and Chips C8 Treatment Frequency: Single Treatment Additional Treatments: None Medications: None</p>

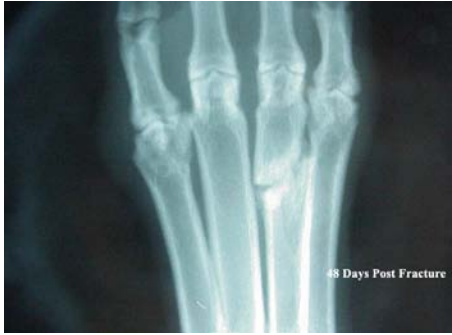
<p>48 Days Post Fracture</p>	<p>Outcomes: See Image</p>

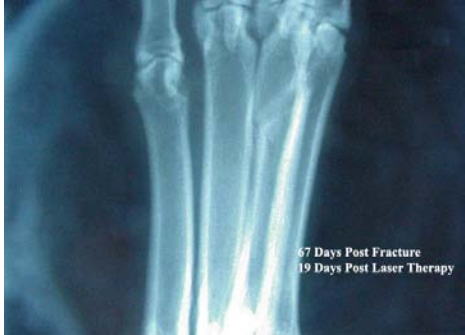
<p>67 Days Post Fracture 19 Days Post Laser Therapy</p>	<p>"...the laser was used over a nonhealing fractured metatarsal on an older rottweiler. At seven weeks we were facing a malunion at which time we used the laser on a bone setting of 4 Hz. Nineteen days later, as our staff and board certified radiologist evaluated the radiograph, there was simply a feeling of disbelief. I hesitate to overstate this, but I have seen enough malunions to know what was accomplished here. The fracture site was healed."</p>
